Boothbay-Boothbay Harbor Schools Community Presentation

LAVALLEE | BRENSINGER ARCHITECTS

Existing Conditions Study

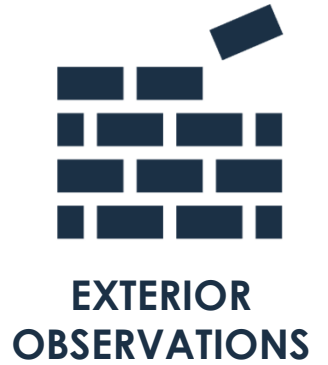
BRHS ●

The exterior envelope of the original 1954 building is not properly insulated and is **NOT ENERGY EFFICIENT**.

- Replace roof (BRHS)
- Repair roof leaks (BRES)
- Replace doors and windows (BRHS + BRES)
- Brick repair (BRHS + BRES)

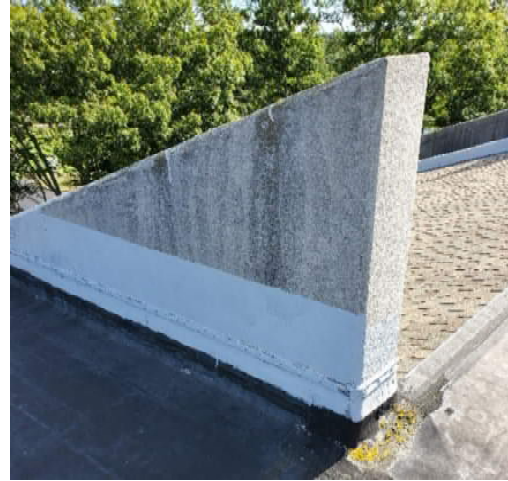
BRES ●

The exterior envelope of the building is not properly insulated and is **NOT ENERGY EFFICIENT**. There are also several areas where the **ROOF IS LEAKING** and is believed to be happening where the roof flashing has failed.

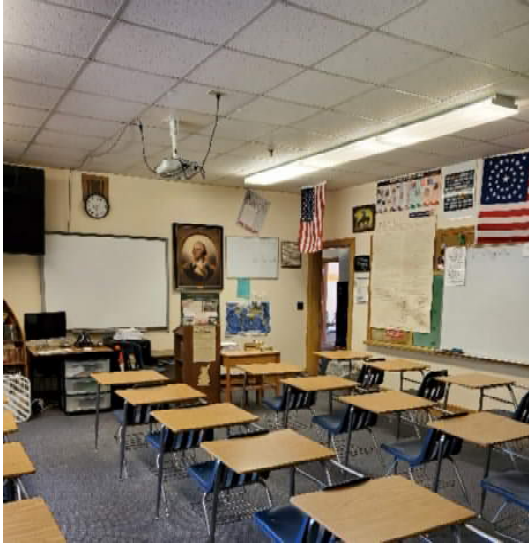
BRHS ●

Many classrooms and labs are **UNDERSIZED AND ODDLY SHAPED** per the Maine Department of Education standards. The technology and electrical distribution are **POORLY INTEGRATED** within the classrooms.

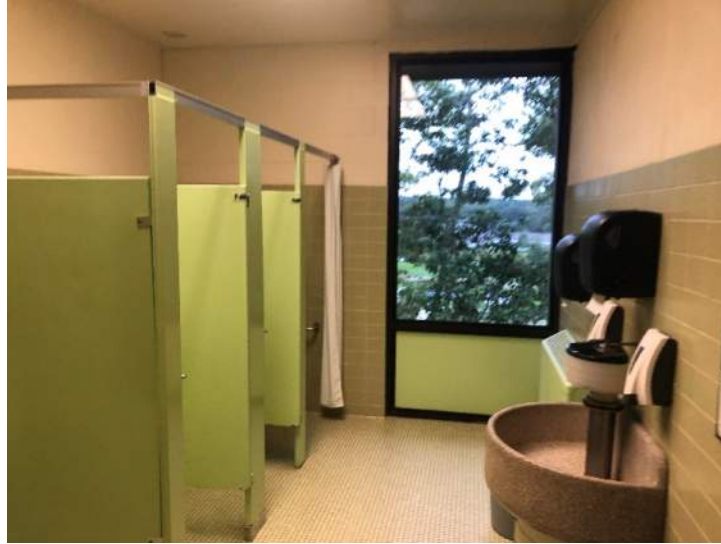
BRES ●

Gang bathrooms and single user bathrooms are undersized and **DO NOT MEET ADA** standards. Bathroom fixtures vary in age and condition. There are **NO STAFF BATHROOMS** in the school.

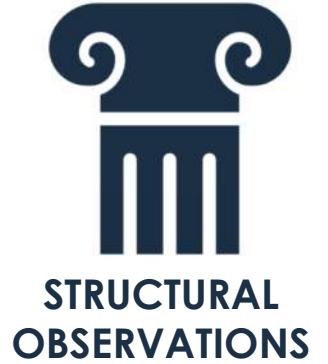
BRHS ●

There are several **STRUCTURAL CRACKS** that have developed in the original CMU walls located in the gymnasium and the stairwells. If left unaddressed, these cracks could worsen and diminish the structural integrity of the CMU wall.

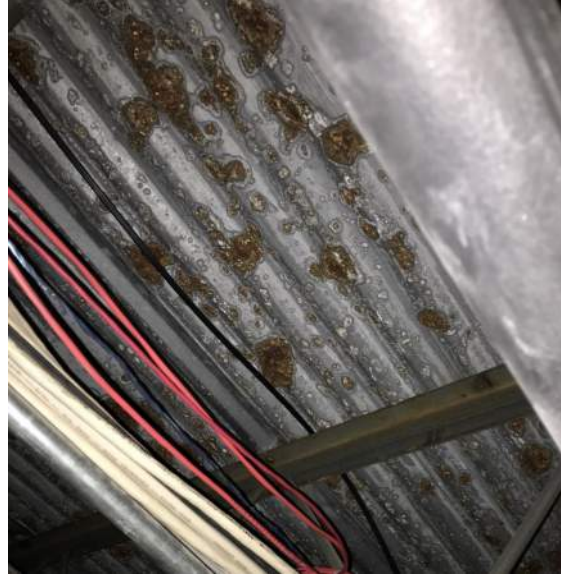
BRES ●

Moisture in the building is collecting on the steel floor decking and other steel structural members causing **RUST** to develop. Rust will deteriorate the steel and diminish the materials structural integrity.

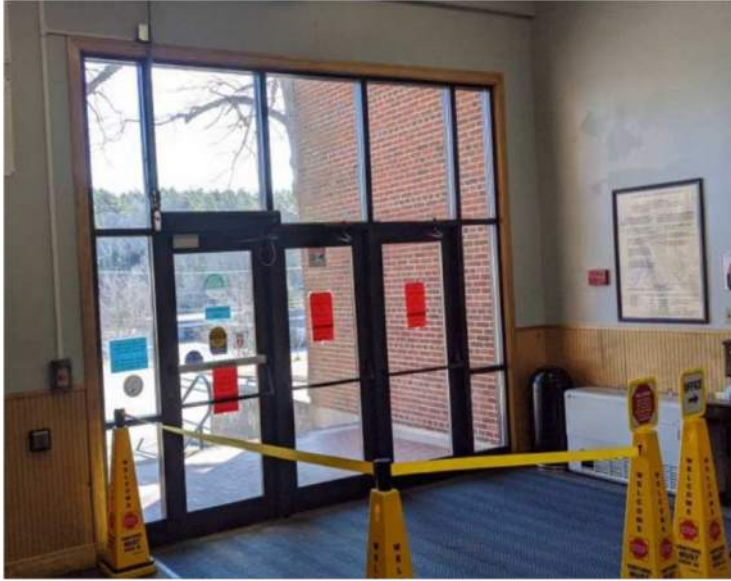
BRHS ●

There have been some security improvements made to the high school but there are still major gaps in the safety + security aspects of the school. The major one is that there are **NO SECURE ENTRANCES** which reduces the school's ability to safely manage visitors.

- Secure main entrance (BRHS)
- Video surveillance upgrades (BRHS + BRES)
- Secure glazing upgrades (BRHS + BRES)

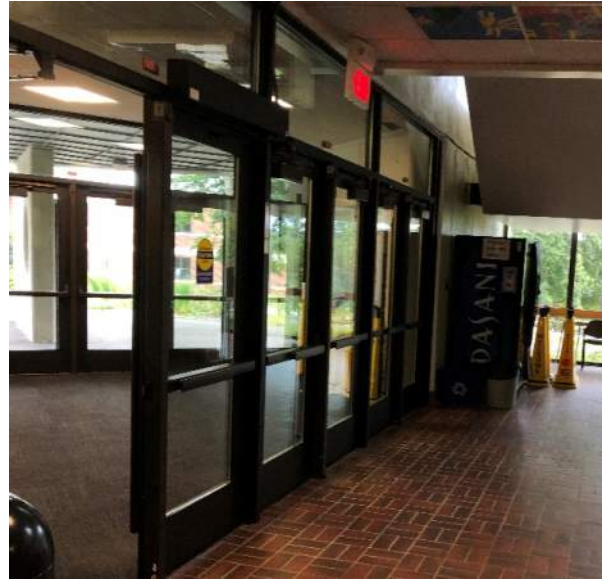
BRES ●

Security upgrades have been made to the school and have created a more **SECURE ENTRY** sequence. However, there are still areas where improvement can be made. Impact resistant glazing at all on grade windows as well as an HVAC emergency shut-off to prevent foreign substances from being introduced into the buildings air flow would increase safety.

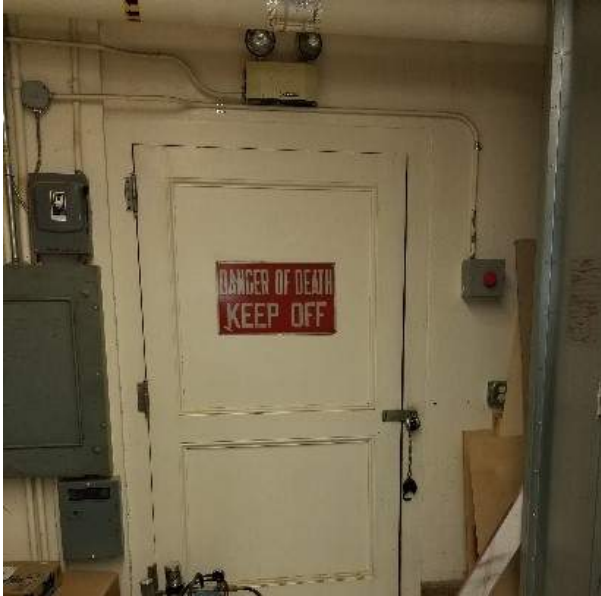
BRHS ●

Transformer vaults and main electrical distribution panels are located within **STUDENT OCCUPIED AREAS**. These should be located in a fire rated room and built to current construction + code requirements.

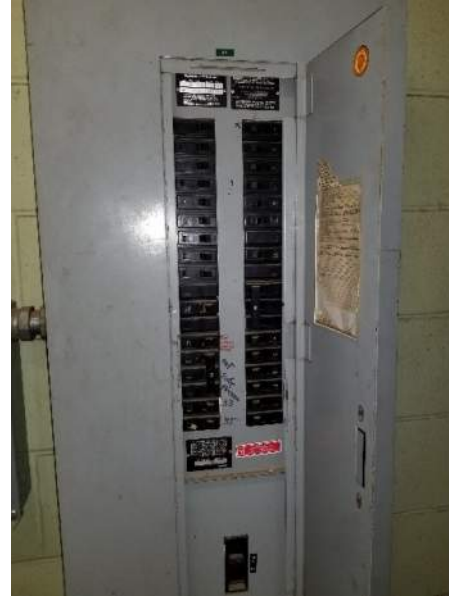
BRES ●

More than 75% of the power distribution equipment are original and **BEYOND THEIR USEFUL LIFE EXPECTANCY** and should be scheduled to be replaced.

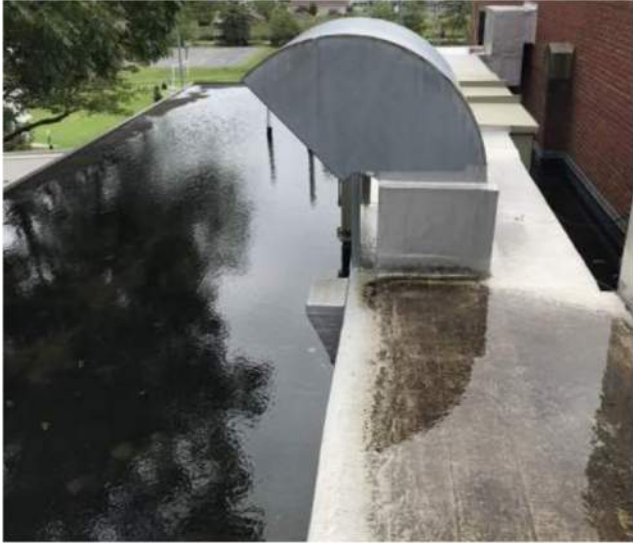
BRHS ●

Copper distribution system for domestic water, and cast-iron piping system for wastewater, are **FAILING** and should be scheduled to be replaced. Roof drain over administration wing is **UNDERSIZED** and does not provide enough drainage capacity for the roof.

- Replace mechanical system (BRHS)
- Upgrade electrical system (BRHS + BRES)
- Replace copper pipe distribution (BRHS + BRES)
- Replace plumbing fixtures (BRHS + BRES)
- Classroom technology upgrades (BRHS + BRES)

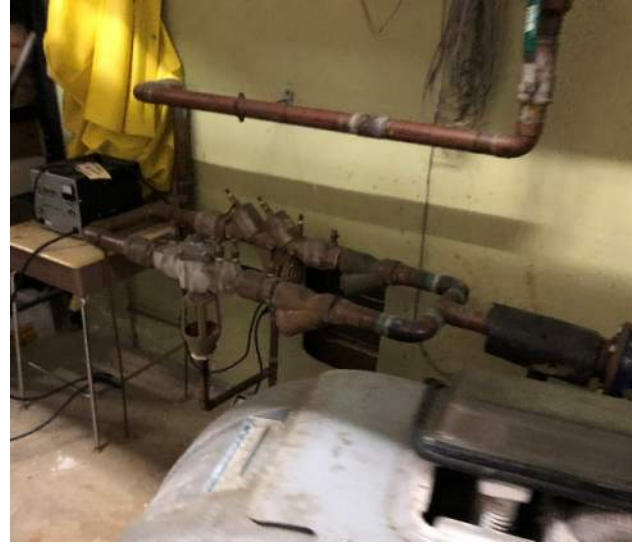
BRES ●

Copper distribution system for domestic water, and cast-iron piping system for wastewater, are **FAILING** and should be scheduled to be replaced.

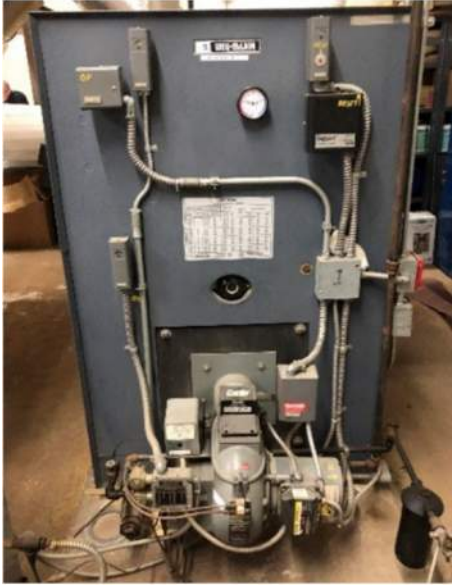
BRHS ●

Air handler units, boilers, and water heaters are at or near the **END OF THEIR SERVICE LIFE**. The complete mechanical system should be scheduled to be replaced.

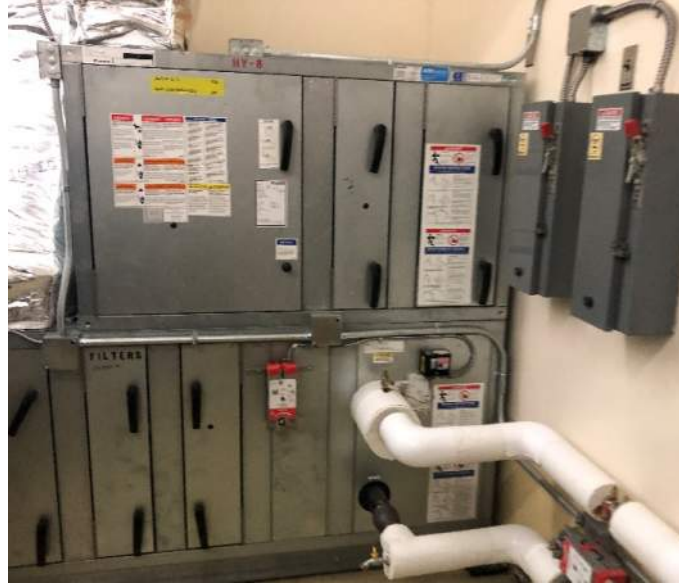
BRES ●

The full mechanical system at BRES is new and is in **GOOD WORKING ORDER**.
